Syke Conservation Area Appraisal

Consultation Draft

Document Title: Syke Conservation Area Appraisal – Consultation Draft

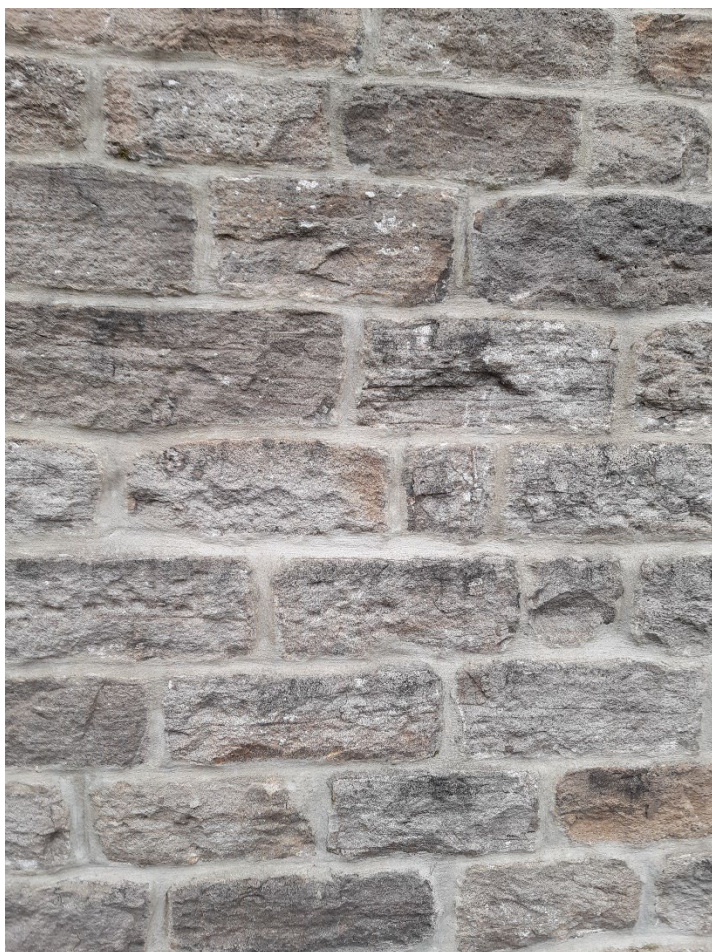
The vernacular buildings, which pre-date the mid-1850s tend to be constructed using locally available materials. These include indigenous sandstone, dressed in the local watershot style. Properties also have stone sills, lintels and architraves. Stone quoins are also evident on some of the former farms.

Figure 17 - example of local stonework

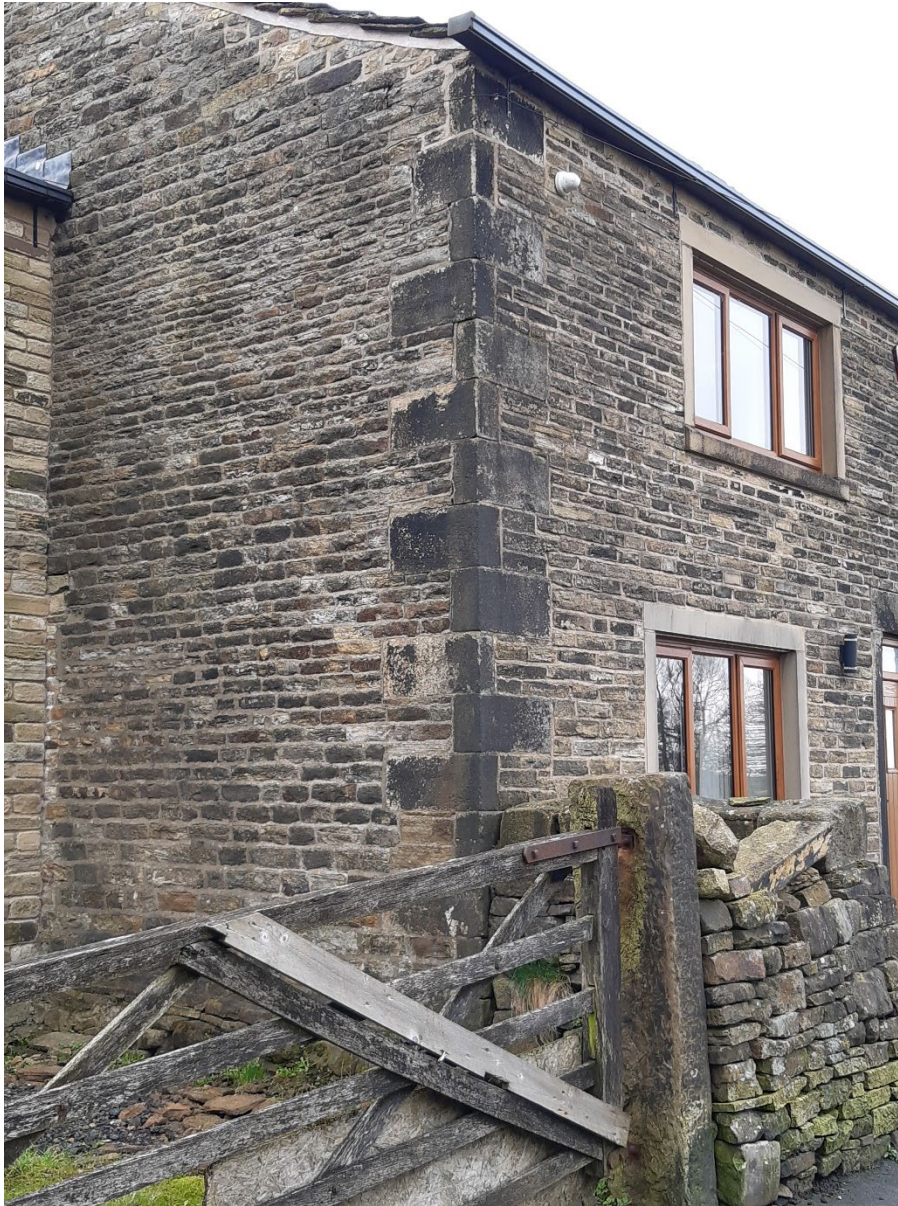
Figure 18 - stone quoins on historic buildings

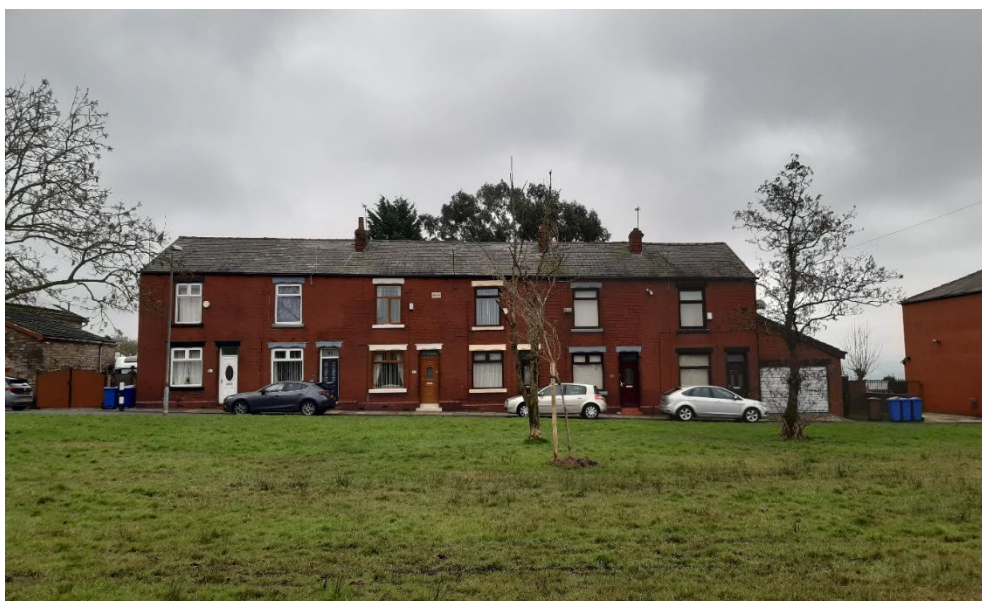
Figure 19 - Late 19th century terraces along Syke Road

The later 19th century terraces which run along the south-eastern boundary of the Common are brick with slate roofs.

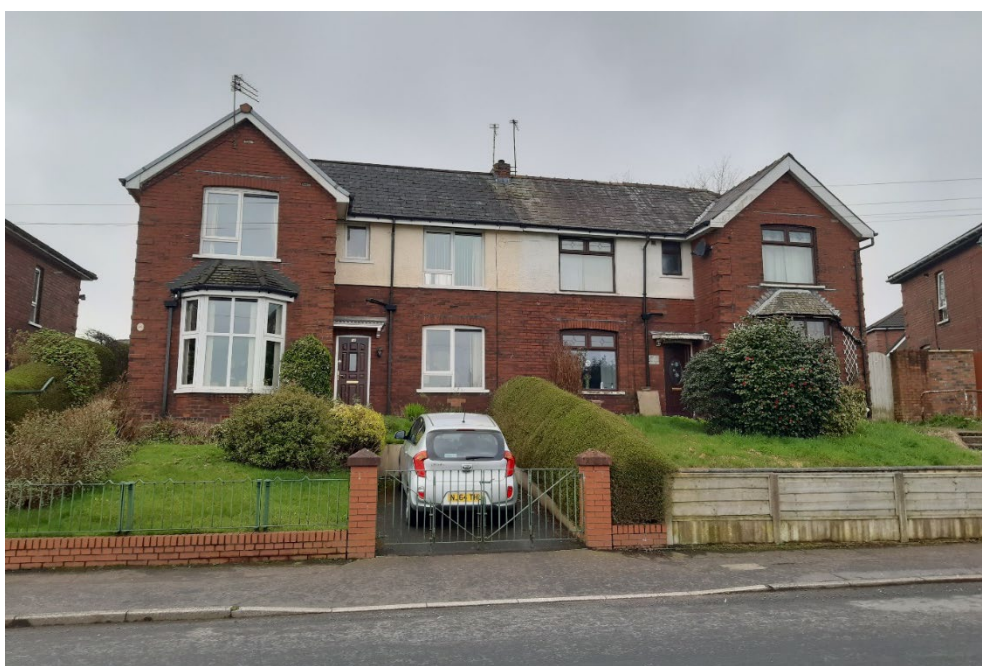
Figure 20 - Interwar housing along Dewhirst Road

Brick and slate continued to be dominant in the interwar housing, on the western side of the Common. Render is also used for detailing on upper stories.

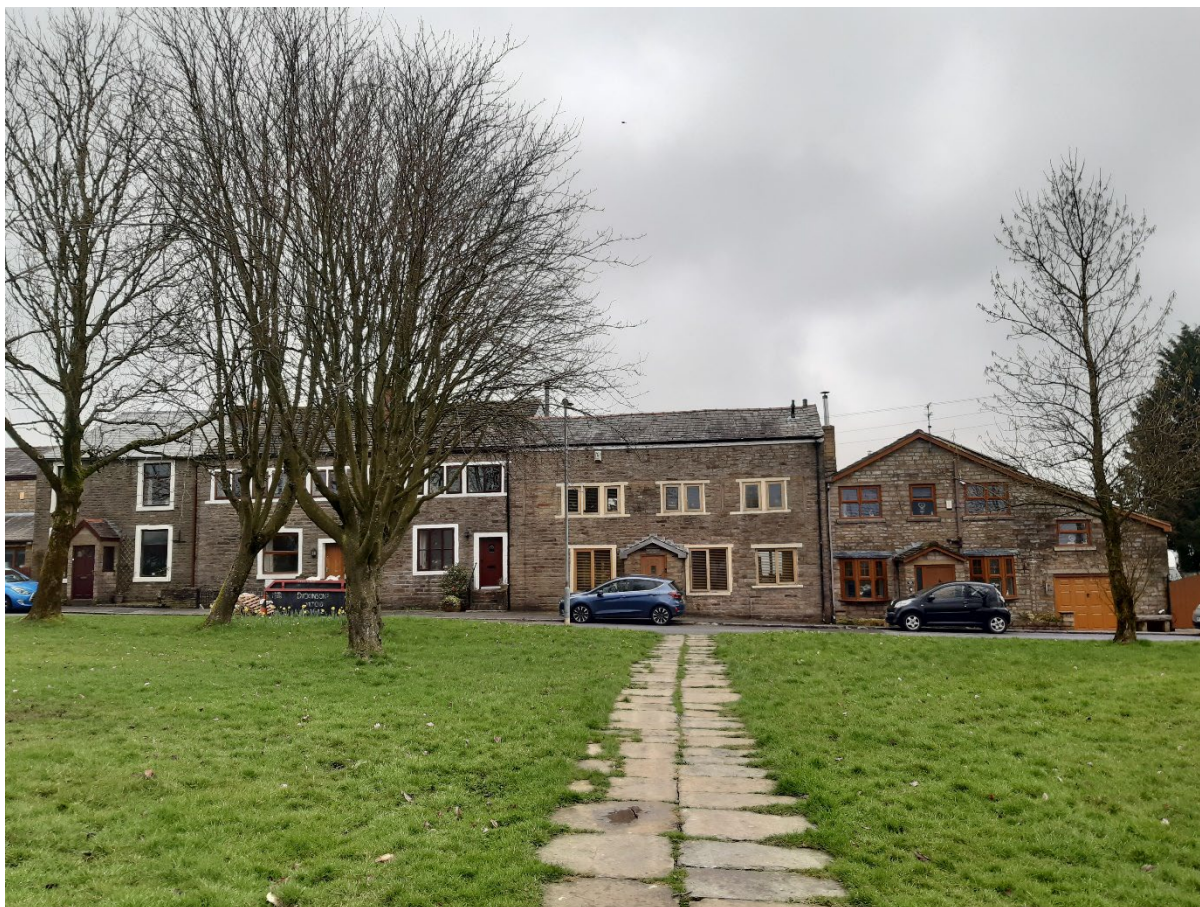
All of the cottages are built of watershot stone, and would originally have had stone roofs. While 101 and 102 Syke Road still have stone roofs, the roof on 100 Syke Road has been replaced with slate. The upper floors of the cottages would have been used for weaving, which is evident from their distinctive window ranges.

101 and 102 Syke Road are listed at grade II. 100 Syke Road was delisted in 2021, but is still identified as a non-designated heritage asset.

Figure 21 - Weavers cottages at 100 to 102 Syke Road and Barm Hall

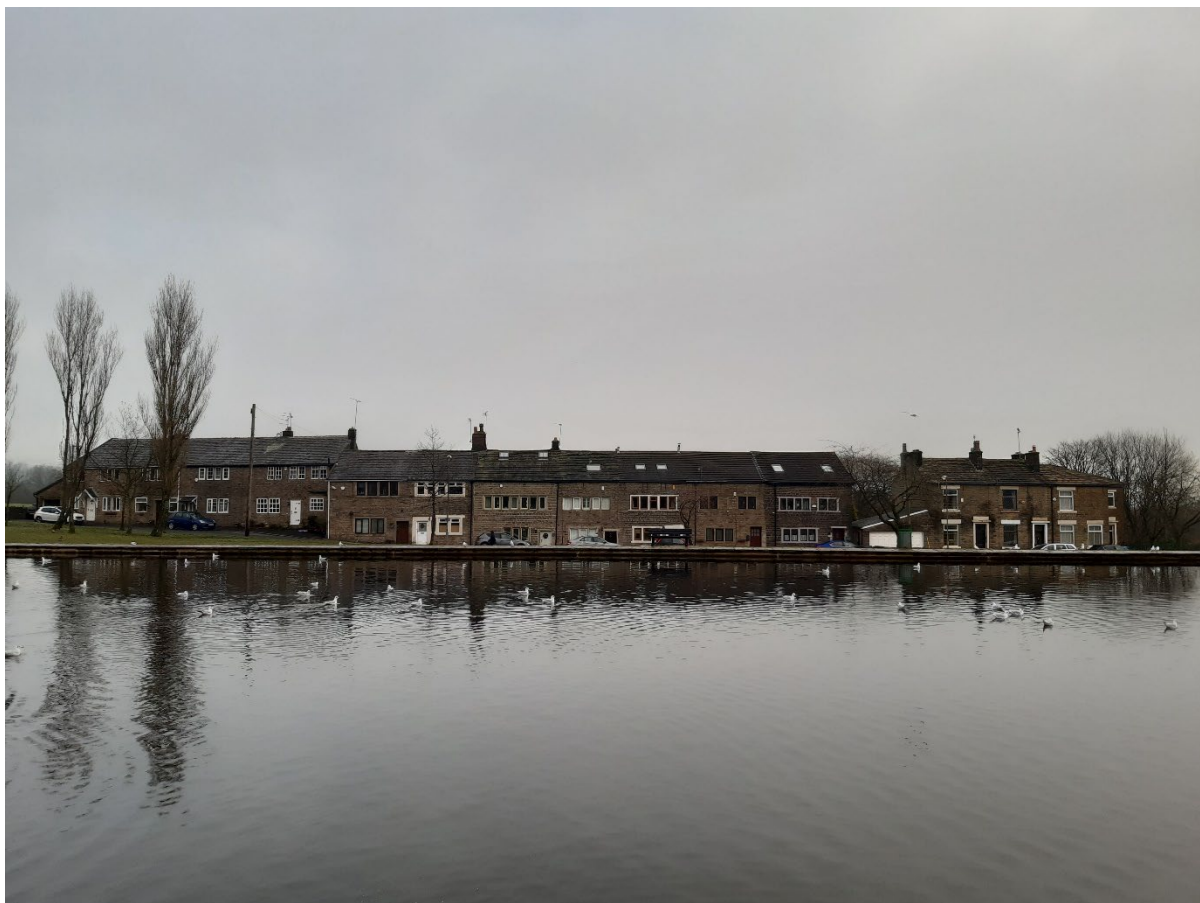
The earliest houses within the terrace, 144 to 148 have the upper floor windows set well below the eaves level. This would likely have allowed for the loft space to have been used for accommodation.

Figure 22 - Weavers Cottages at Polly Green, Syke Road

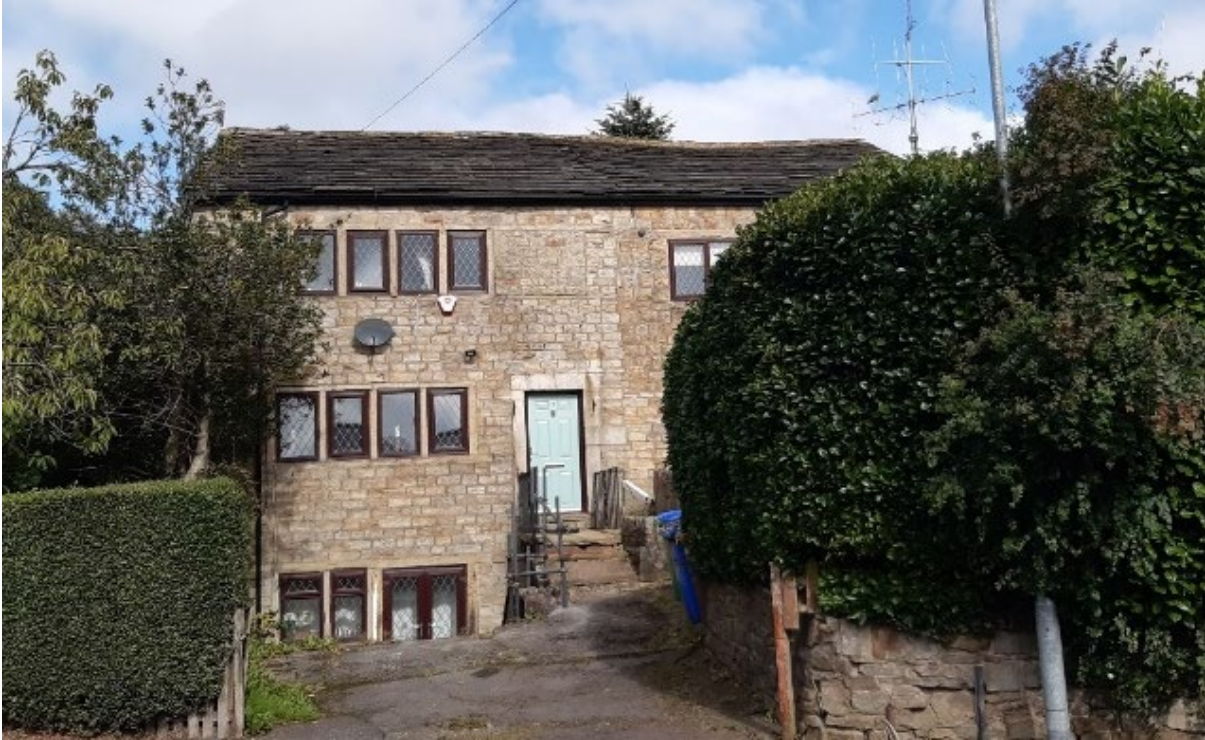
Figure 23 - Weavers Cottages at 6 and 7 Poot Hall

This pair of cottages are shown on the first edition OS map from 1851. They are three storey and constructed in watershot stone, with the distinctive run of windows on the upper floor that marks them out as weavers' cottages. In appearance, they are similar to the listed 190 to 192 Dewhirst Road.

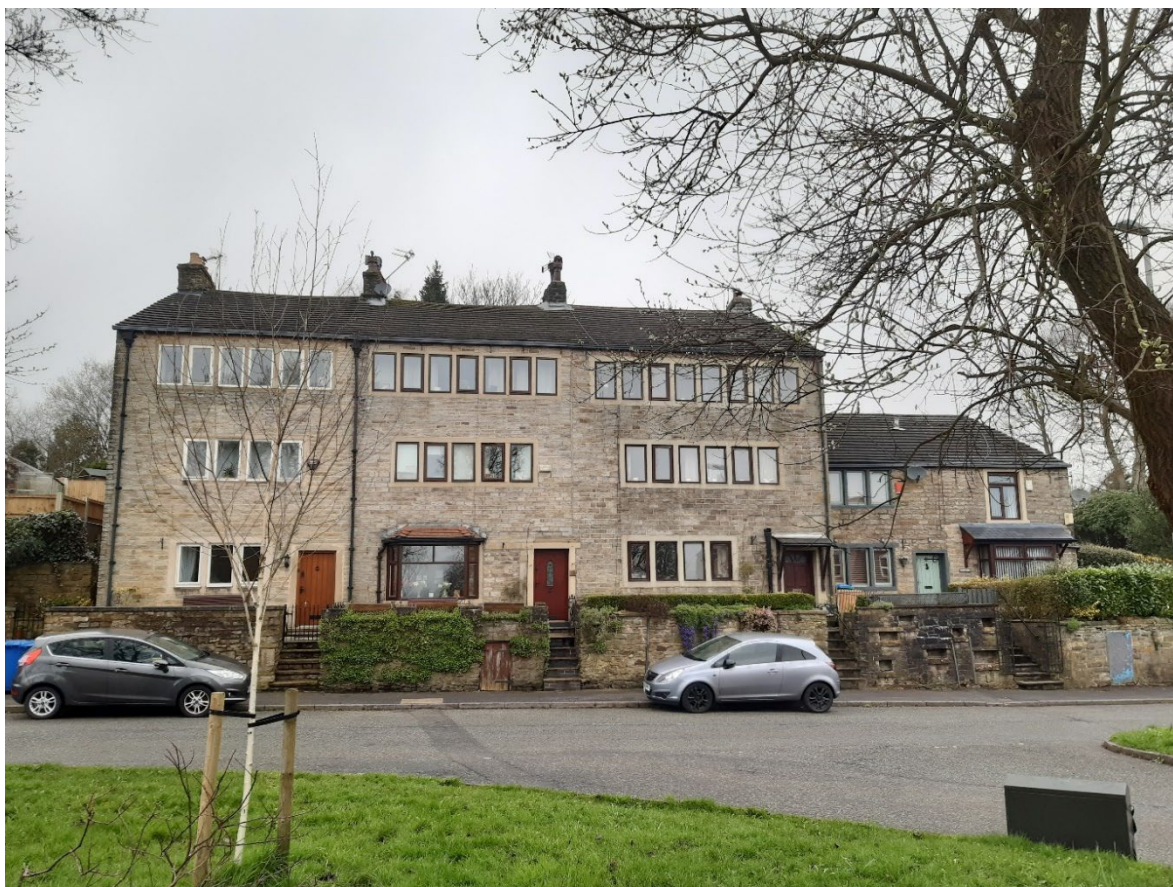
Figure 25 - Weavers Cottages at 190 to 192 Dewhirst Road

This run of three houses dates from around 1800. They are three storey and constructed in watershot stone. As with the other cottages in the area, they would originally have had stone roofs. These have been replaced on 191 and 192 with modern 20th century tiles.

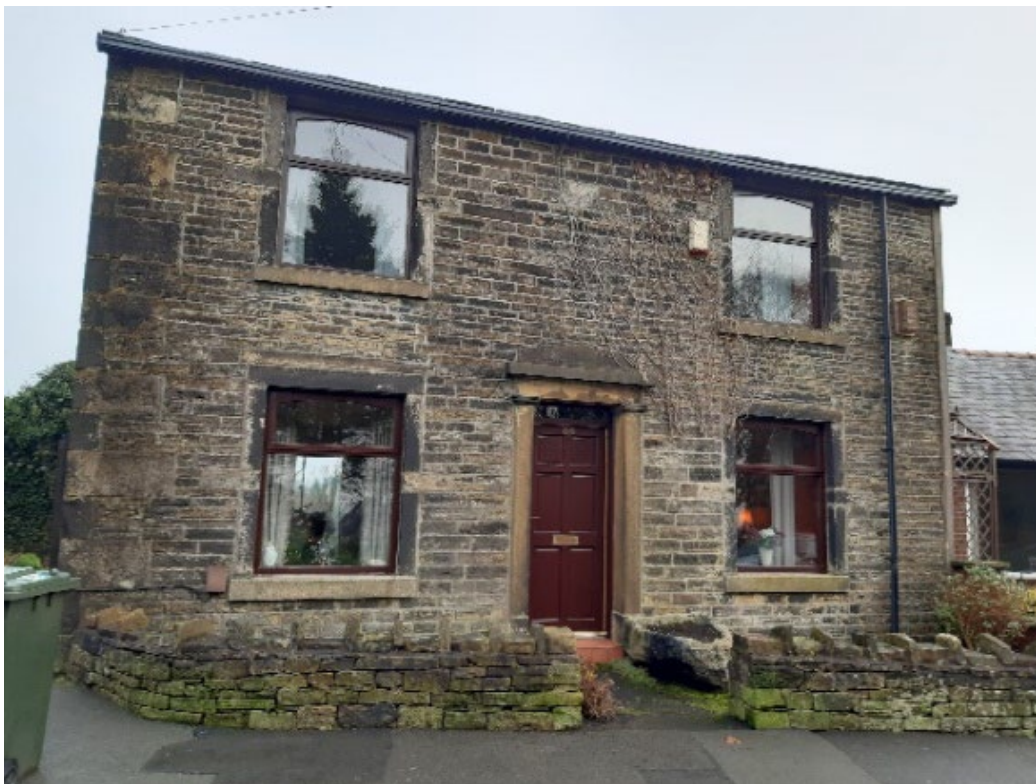
Today the only part of the range that survives is the old farmhouse. The quoins which are only present on the northern elevation and the rendered wall on the southern elevation all indicate that the existing house was once part of a larger building.

Figure 29 -Farmhouse at Cross Lees Farm

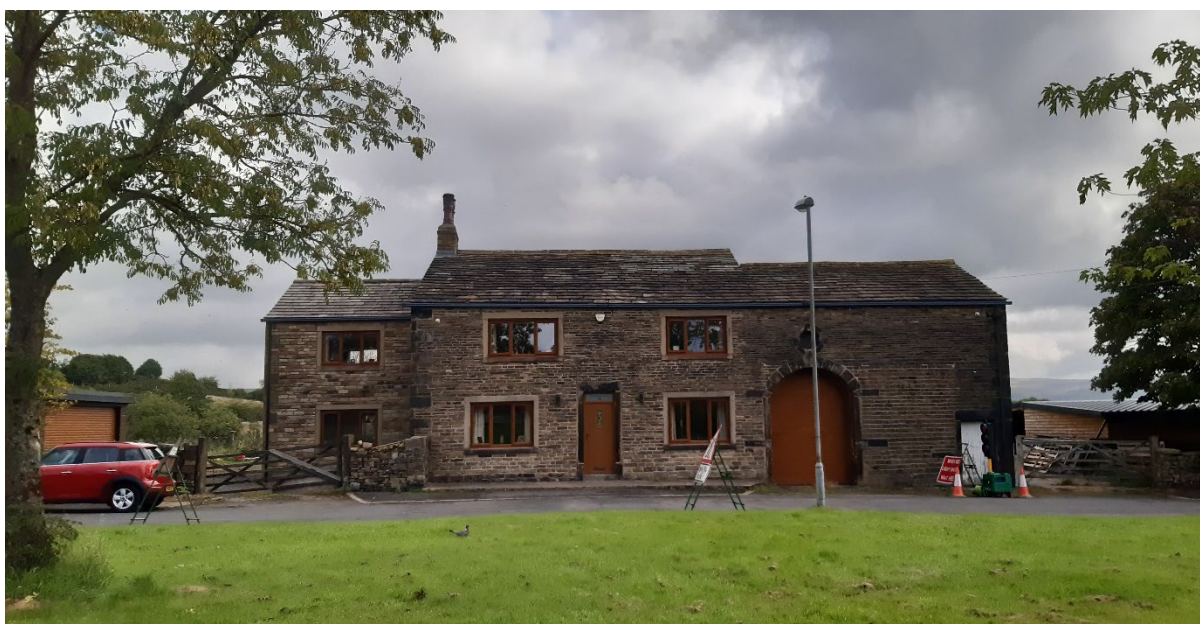
This former farm is now in residential use. At first glance, its linear form and the combined agricultural and residential uses indicate that it could be a laithe house. However, the barn appears to be a later addition, as it has a lower ridge than the farmhouse.

Figure 31 - Hazel Grove Farm

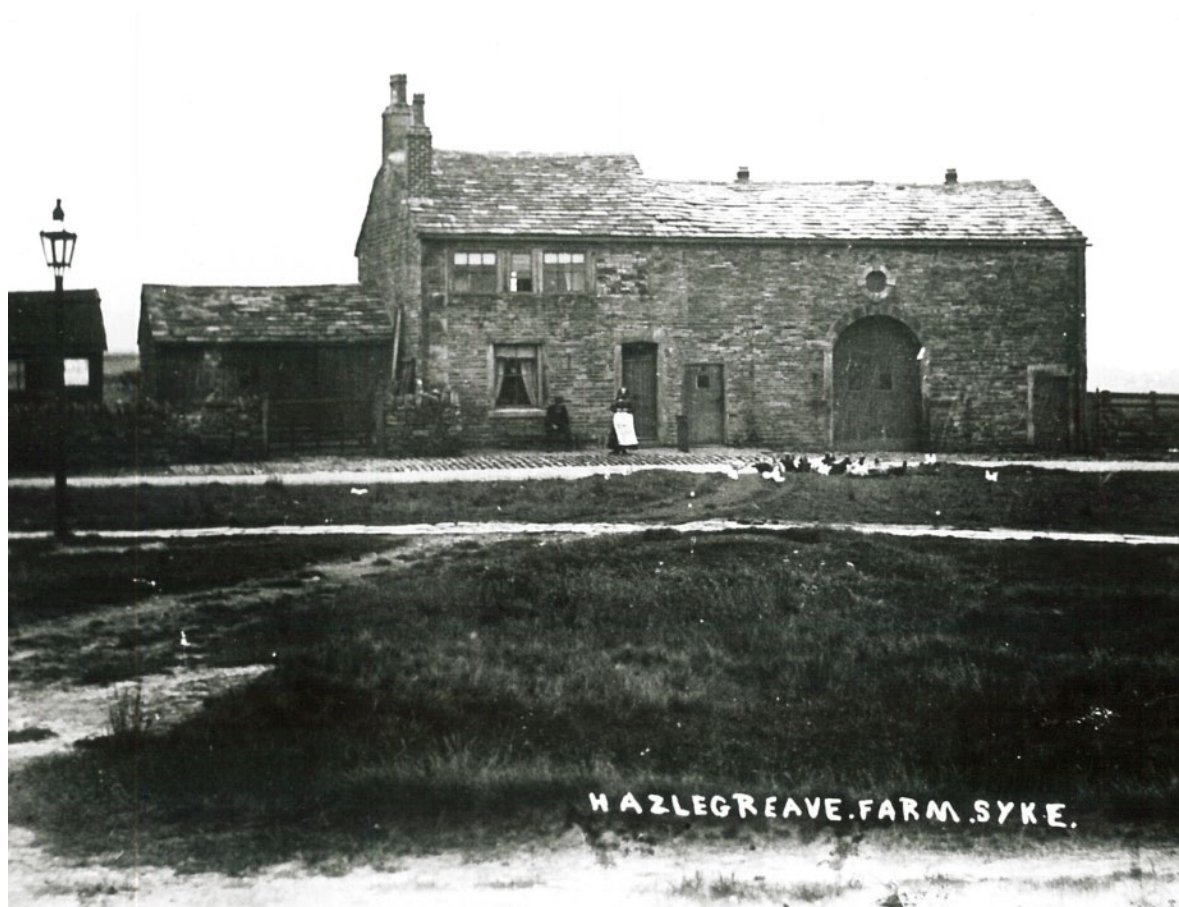
Figure 32 - Hazel Grove Farm (undated)

The building appears to have undergone several alterations and different uses during its history. Early photographs show the house having a continuous run of upper floor windows, and a single window at ground floor level, indicating that it was used for weaving. The building was converted to residential use in the late 20th century.

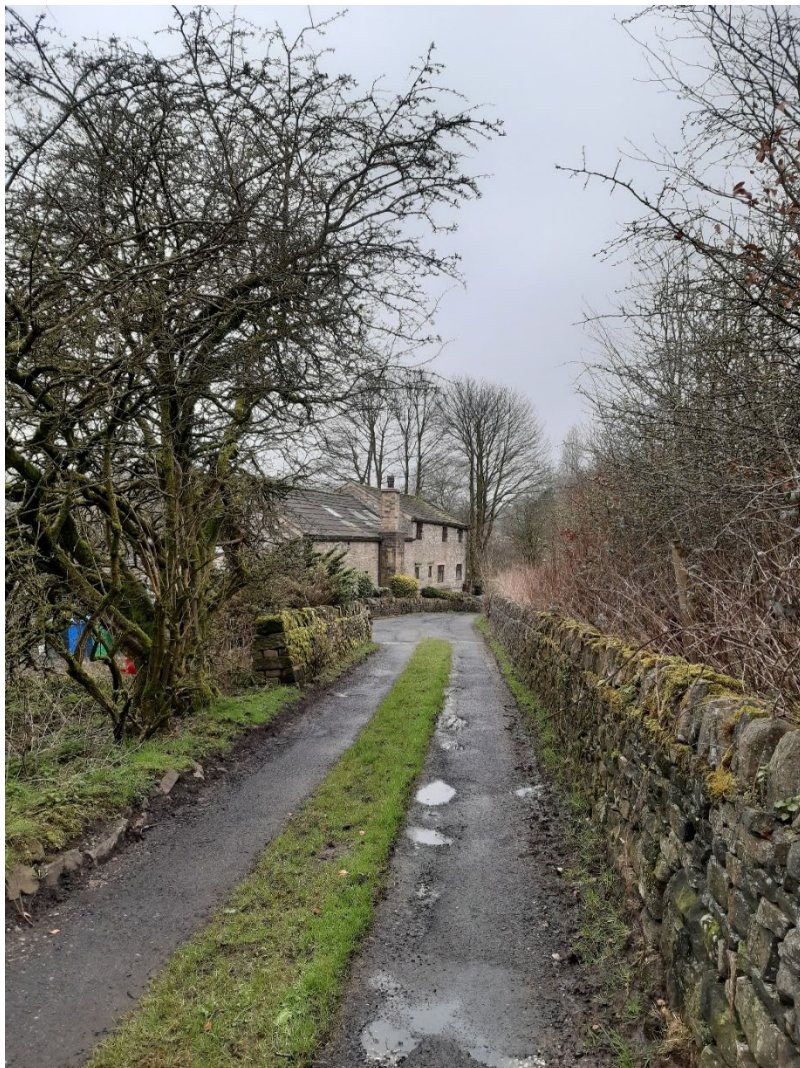
Syke Farm on Ringlows Lane to the north of Syke is also present on the 1851 map. The building has a date stone from 1612, but appears to have been significantly altered and extended. Other than its name and linear form, few traces of its former agricultural use appear to remain.

Figure 33 - Syke Farm, Ringlows Lane

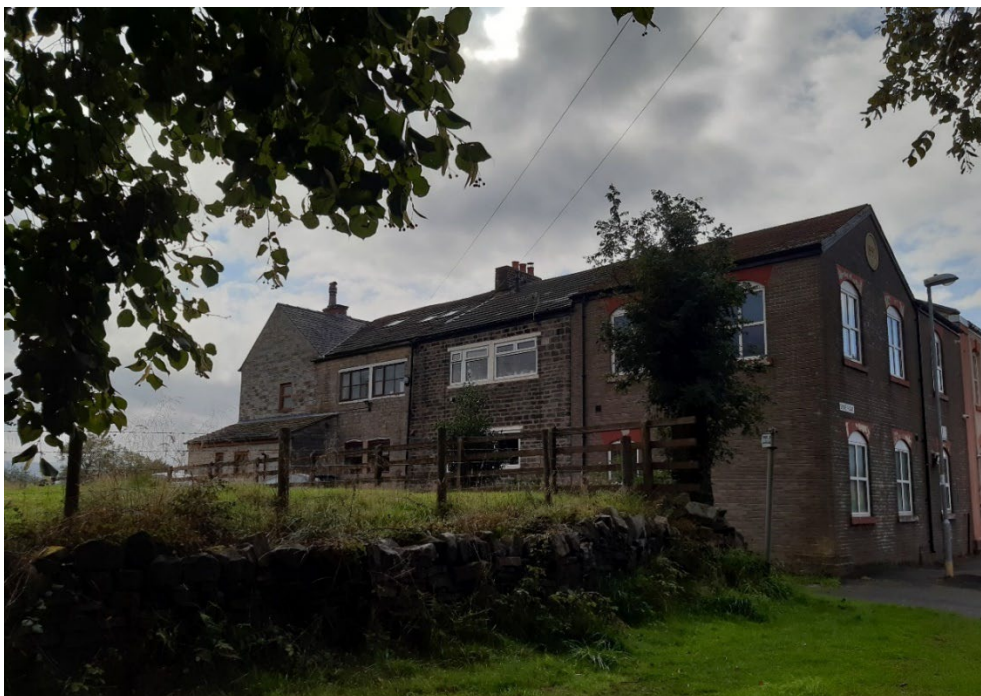
Figure 35 - Chapel and Cottages

Syke Methodist Church sits at the northern most point of Syke Common. It was constructed in 1868 and opened for worship in 1869. One cottage was demolished to make way for the Church but other weavers' cottages were retained and survive as part of the complex today.

The exterior of the building has been re-rendered, the chimney has been removed and the windows have been extended. The northern wing was replaced with a brick extension in 1991. All of these changes have degraded the building's architectural interest, but some features remain, such as the arched lintels with keystones above the ground floor windows and southern entrance.

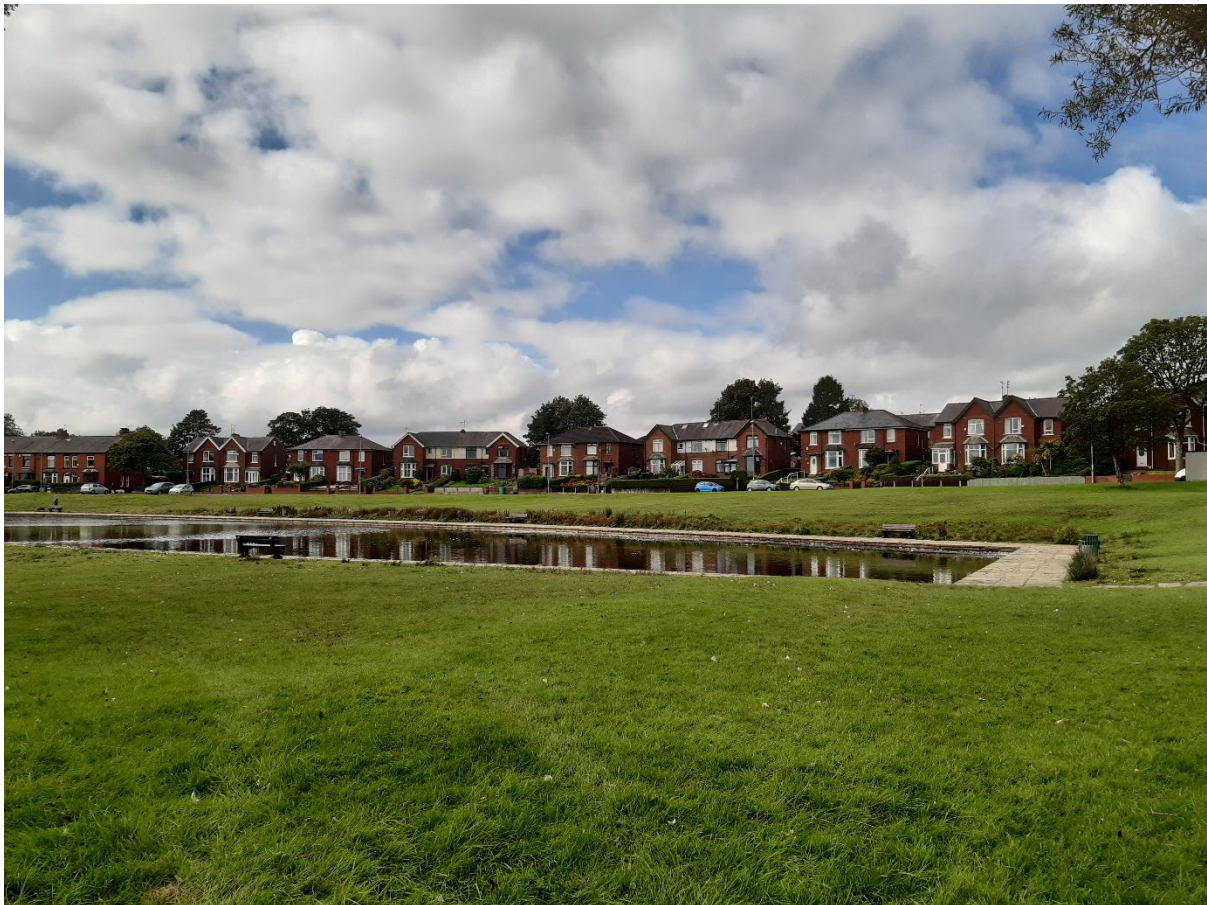
Figure 39 - Interwar housing along Dewhirst Road

The interwar houses are mainly semi-detached, with some short runs of terraces. Brick and slate dominate, with selective use of render. They are not of the special architectural or historic interest which would merit inclusion in the Conservation Area. Nevertheless they still provide an attractive backdrop to the Common.

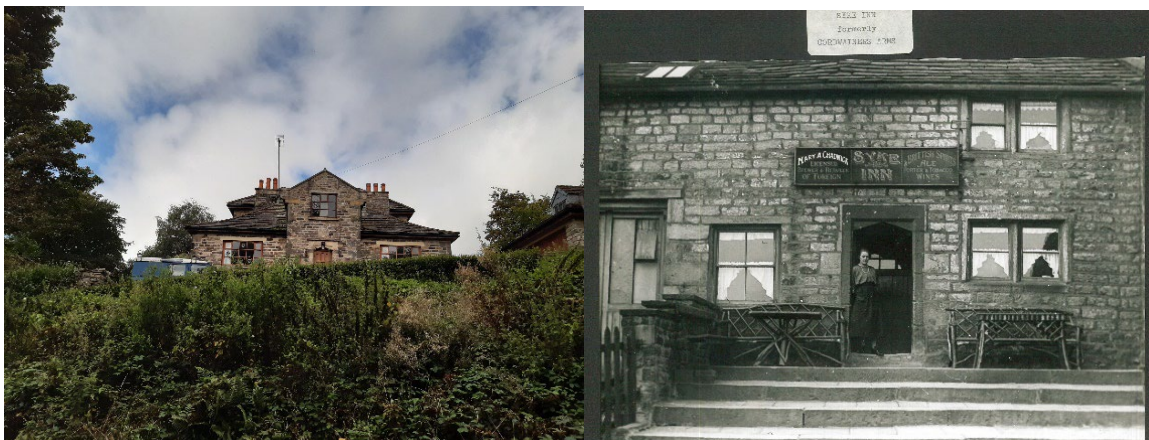
Figure 40 – House on the site today (L) and former Cordwainers Arms (R)

The site of the Cordwainers Arms lay to the north of Syke Common and is to the north of the proposed Conservation Area boundary. It was replaced by a private dwelling in the mid-20th century. Some elements of the old public house appear to have been re-used in the existing house, such as the door surround:

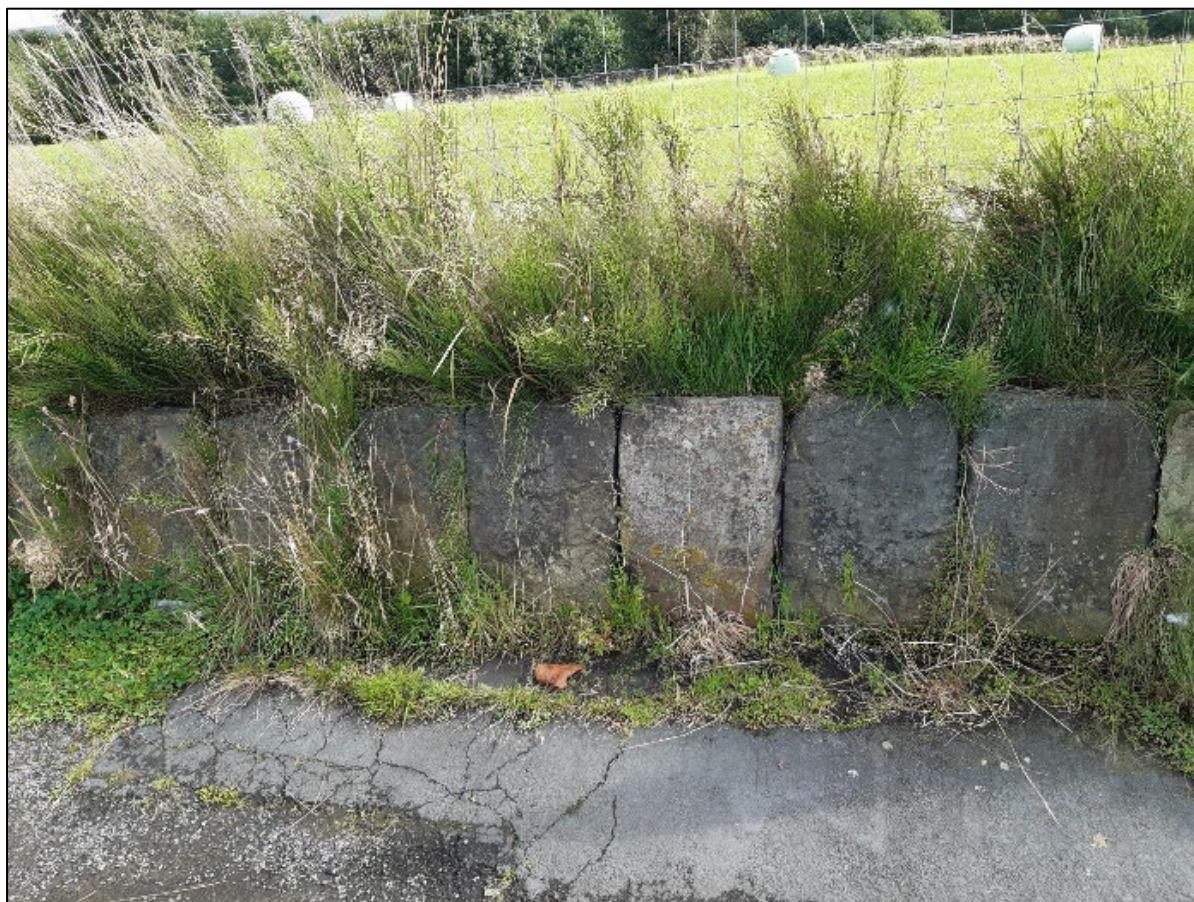
In Syke, there is a low-level flagstone wall which separates Syke Road from the field to the north and the adjoining field for approximately 75m. The flags are distinctive in that they are much smaller than those found in flag stone walls elsewhere. They appear to be acting as a retaining wall in addition to marking the field boundary.

Figure 43 - flagstone wall on Syke Road

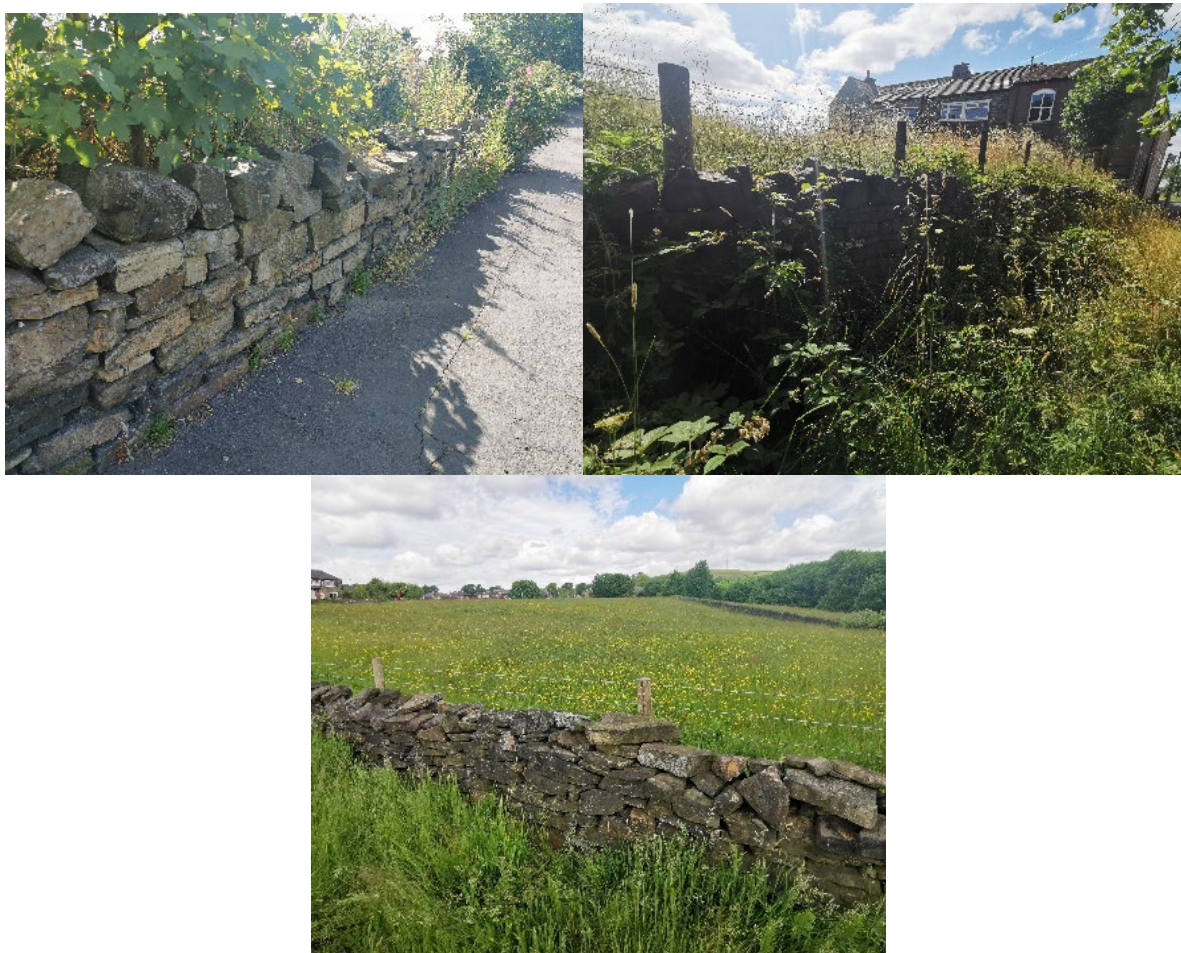
Figure 44 - Examples of stone walls in Syke

Drystone walls are found across the Syke area, particularly to the north and east. A dry stone wall runs from Polly Green to the Methodist Church on Syke Road.

Other stretches of drystone wall are found to the north of the Methodist Church on Dewhirst Road and along Ringlows Lane. As with the flagstone wall further to the south of Syke

Road, these are remnants of the previous field boundaries and are indicative of the former rural character of the area.

Flagstone walls are built of large slabs of stone, erected vertically, held in place by bolts and tightened with metal plates. While not a common feature nationally, they are found across the borough to mark field boundaries and to separate back to backs of terraced housing.

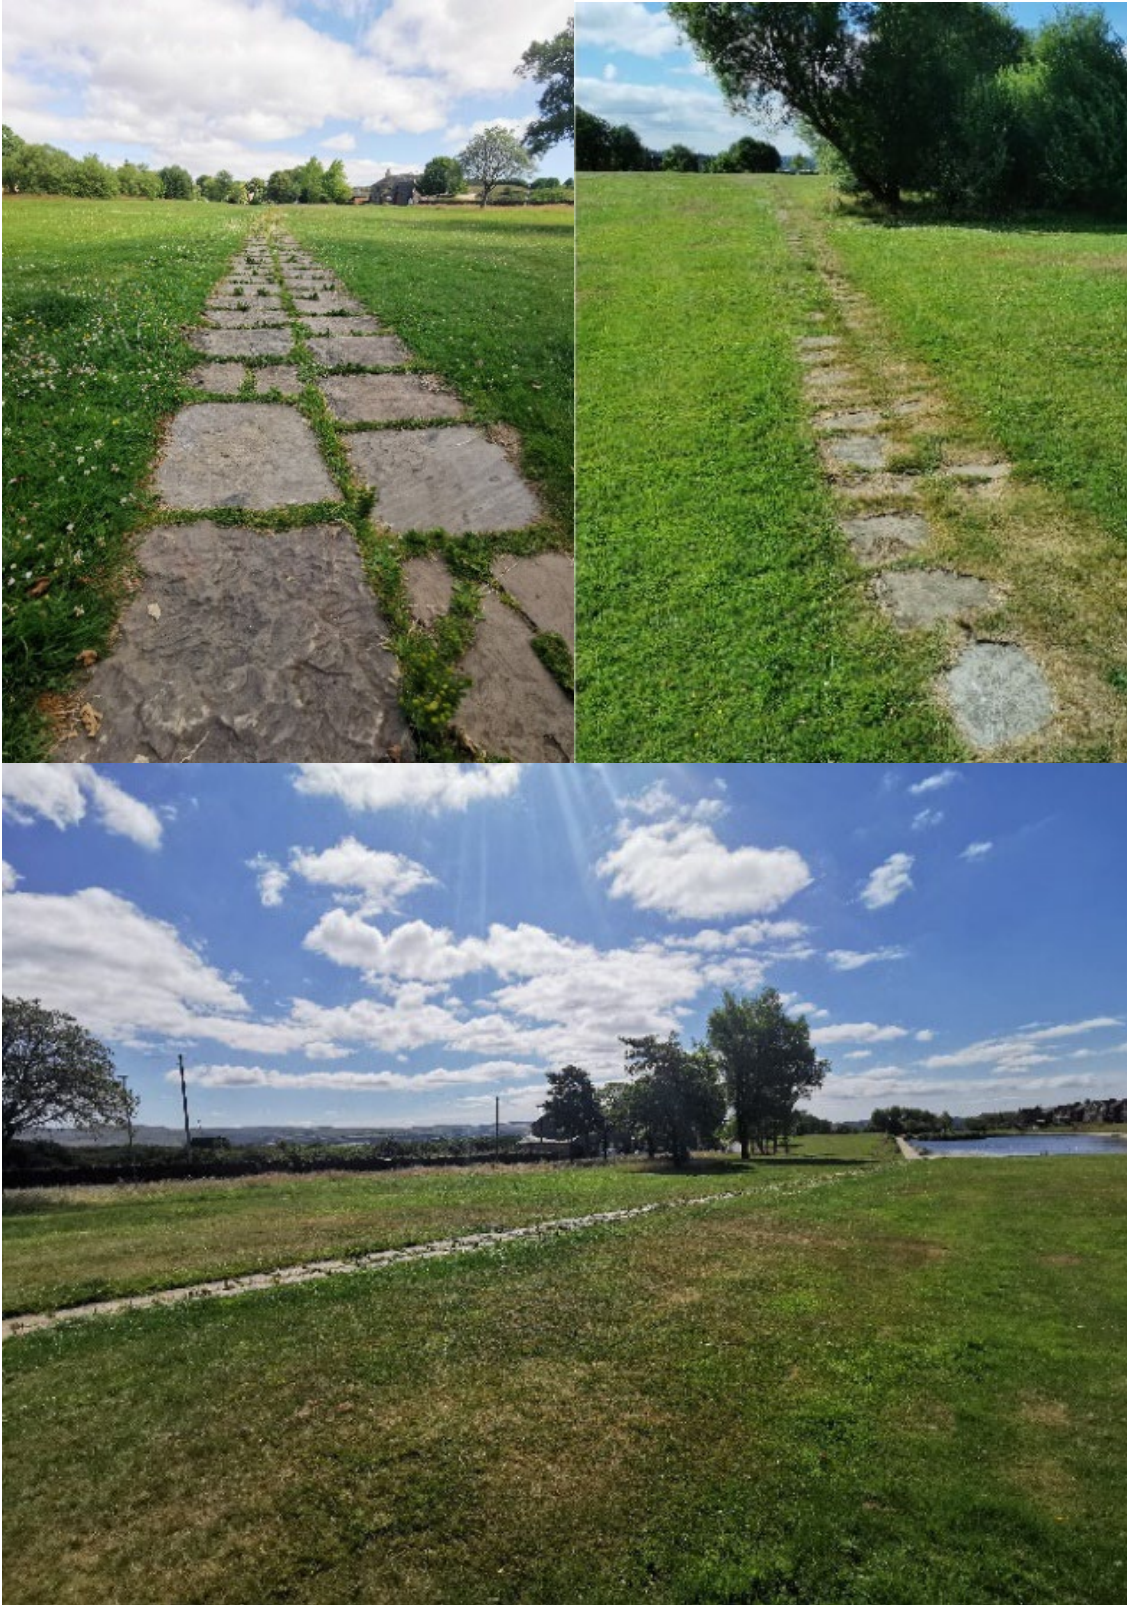
Figure 46 - Historic Paths on Cronkeyshaw Common

It is assumed that modern day Syke Road follows the old packhorse trail. However, there are other historic paths and trails, which criss-cross the Common. It is possible, that one of these trails may have been the original route of the pack horses, or that the horses used various routes depending on conditions. Remnants of these old trails are still visible today.

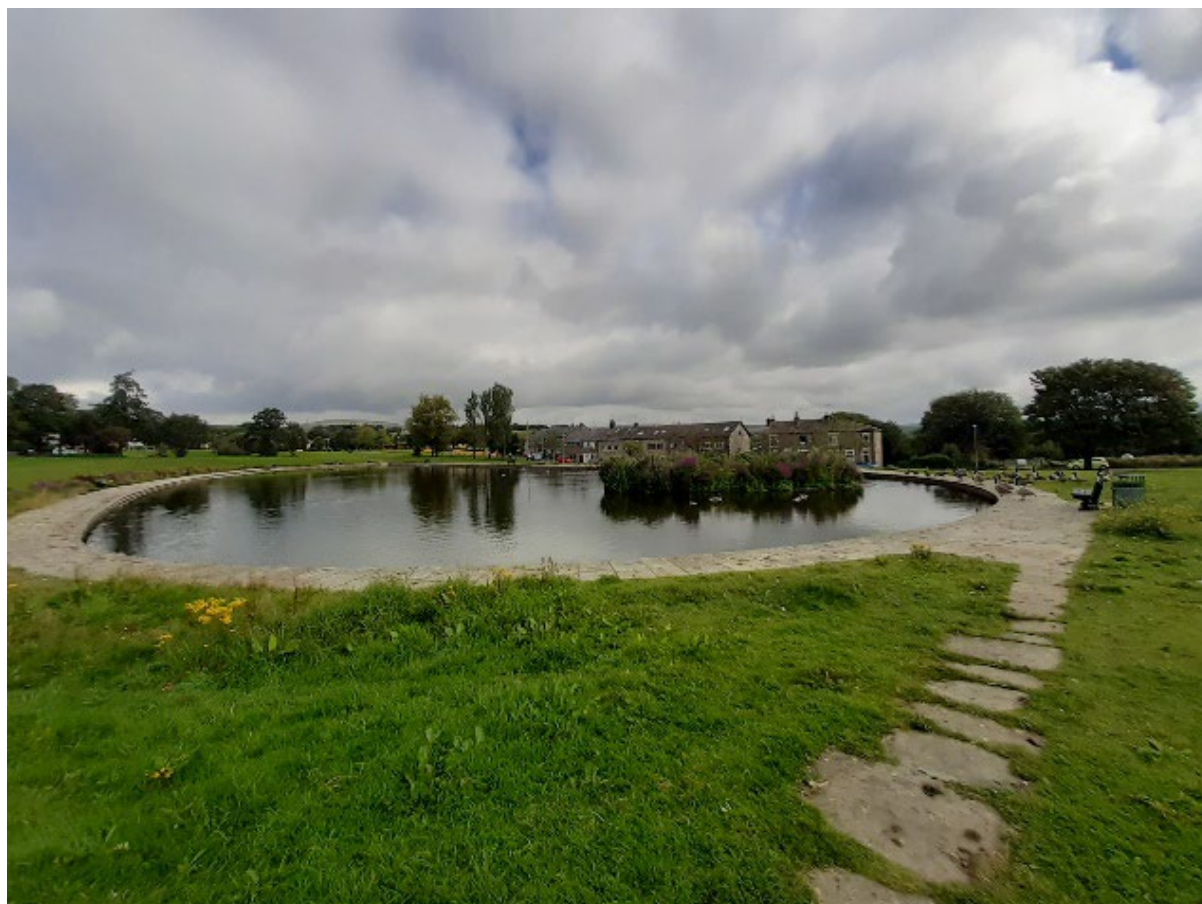
Figure 48 - Syke Pond, Cronkeyshaw Common

Historically, the Common was used for the extraction of clay for marl and brick making. This resulted in the creation of ponds on the land in front of Polly Green. The ponds, along with the views and fresh air of the nearby countryside made the area a natural attraction for nearby Rochdale residents.

In the late 20th century, the condition of the pond and the Common became a cause for concern. A new landscaping scheme and the refurbishment of the paths and pond has largely addressed these concerns.

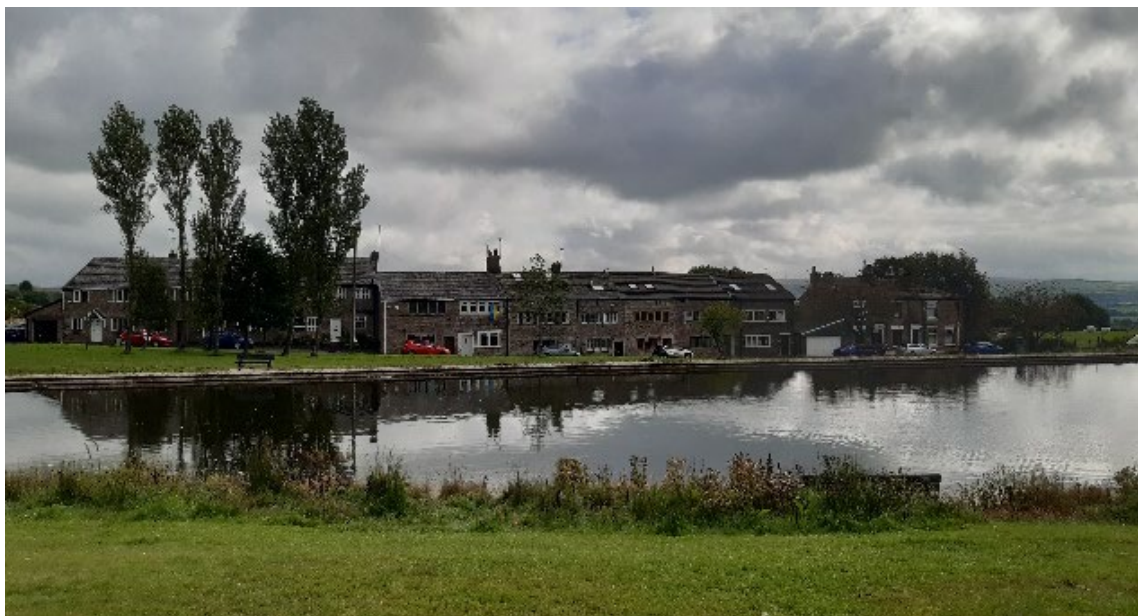
Figure 50 - Syke Pond and Polly Green Cottages

It has been used for paddle boats and yacht racing and it is still much used by people for recreation and to relax. People of all ages walk round the pond or sit and enjoy the views across it, and it is still used often by people with model boats.

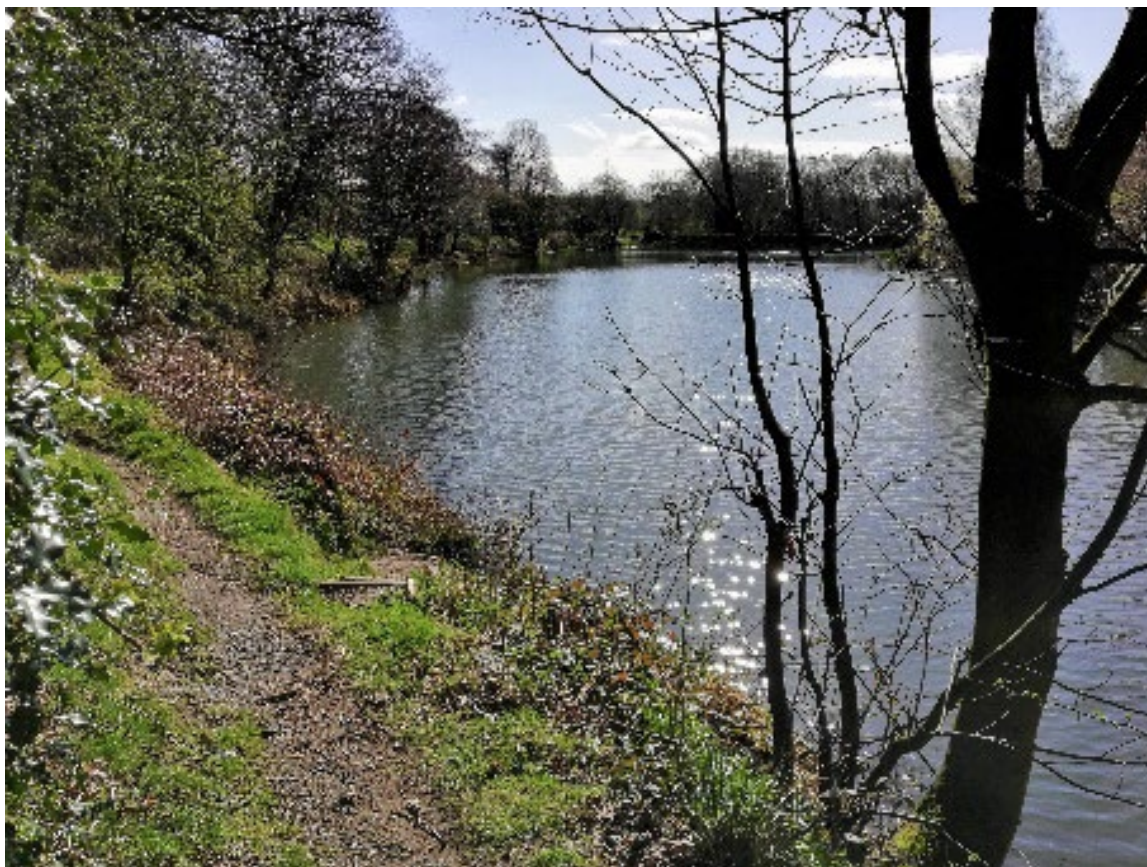
Figure 51 - Reservoir at Buckley Woods

Buckley Wood lies to the east of the ribbon development along Syke Road and the Conservation Area boundary. In 1838 to 1841, the site was chosen to construct three reservoirs to supply water to Rochdale. These were the first reservoirs to be built in Rochdale and are mainly fed by Syke Brook. Only two reservoirs remain today. The third and largest reservoir has been drained.

Syke Woods sits in the basin of the drained reservoir. The woodland has been allowed to grow naturally and is now covered in dense trees and other foliage. One Elder tree in Syke Woods is noted on the Woodland Trust Ancient Tree Inventory, and, together with the other reservoirs, the area is listed as a Site of Biological Importance by the Greater Manchester Ecology Unit.

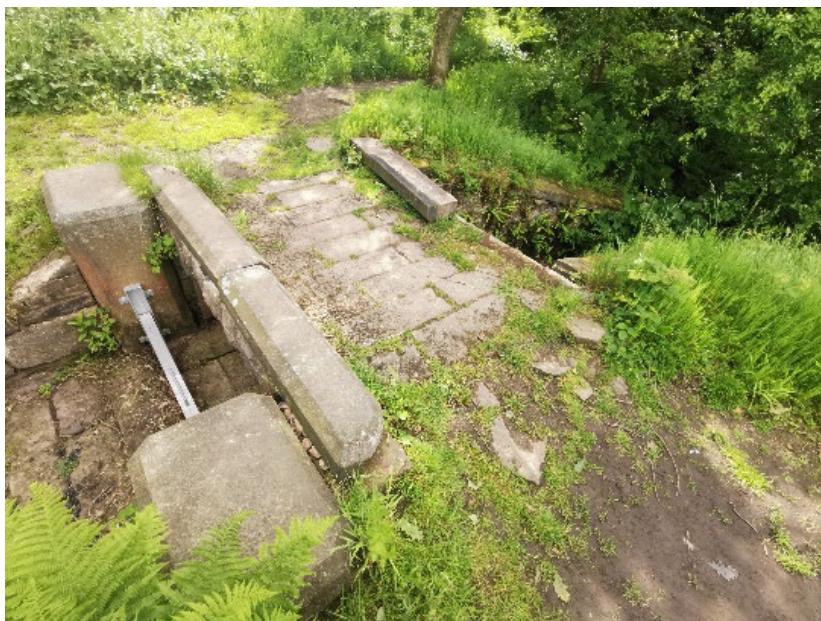
The area's former use is still visible today, in the form of drainage channels, a stone bridge and the dam wall. There are also steps linking Syke Road to the Buckley Wood reservoirs. These would have been used by workers to access the reservoir.

Figure 52 - Stone Bridge associated with the reservoirs
