Syke Conservation Area Appraisal

Consultation Draft

Document Title: Syke Conservation Area Appraisal – Consultation Draft

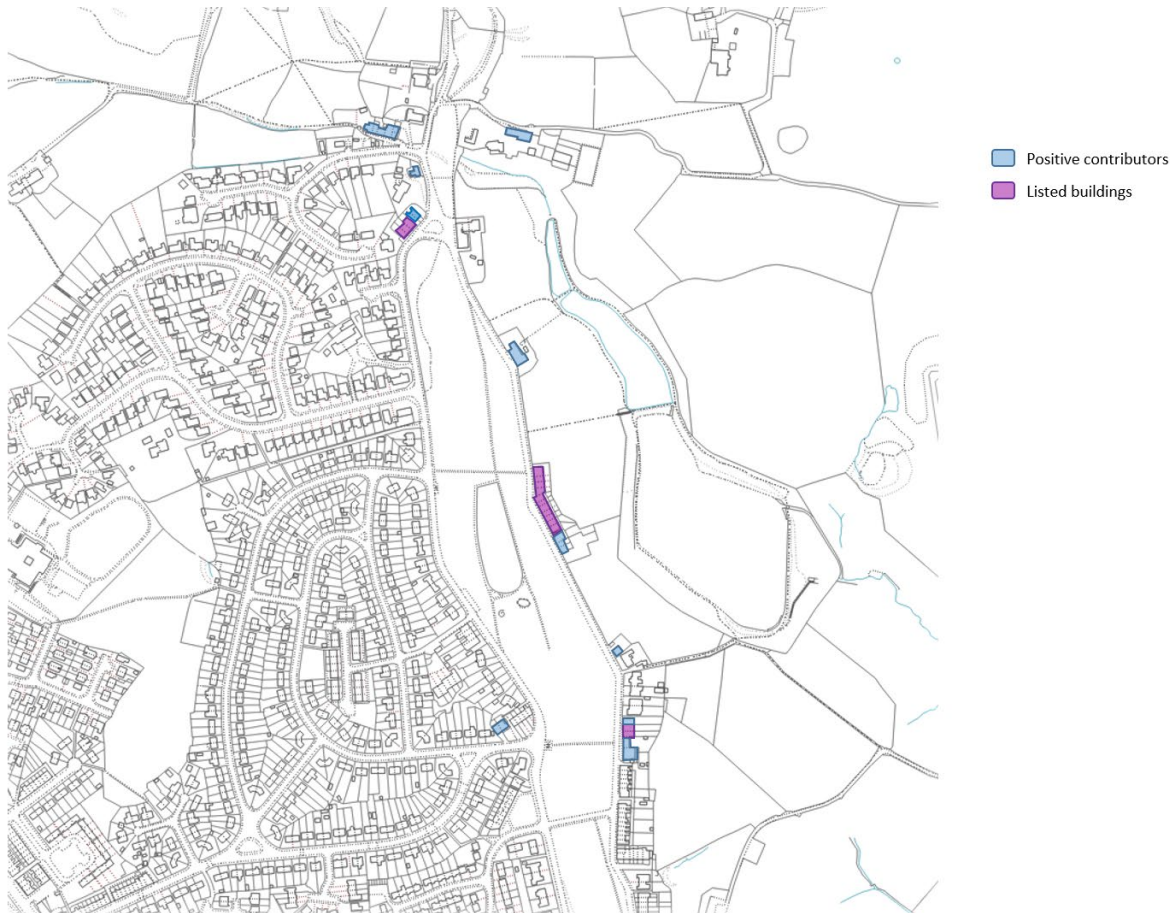
Figure 53 - Contributor Plan

Positive contribution

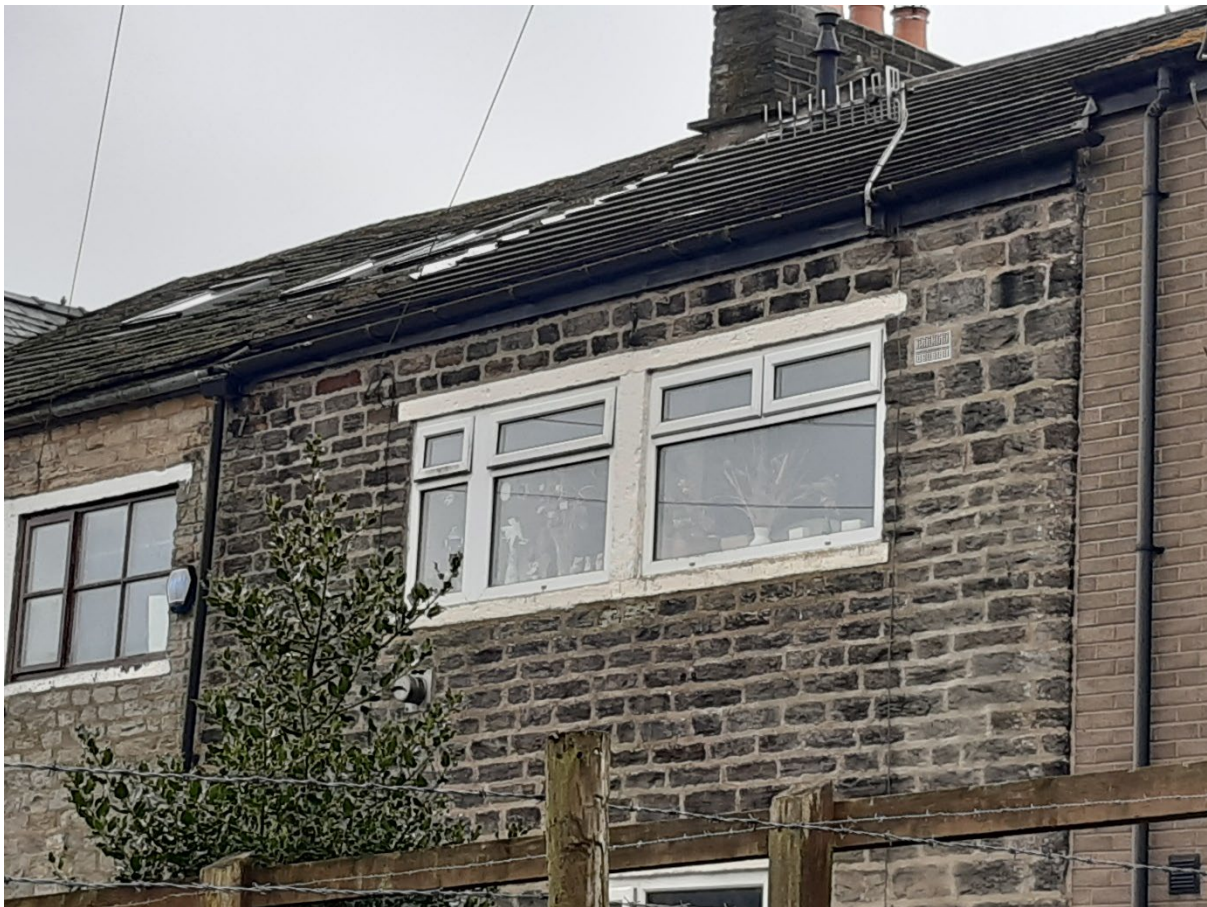
- On some buildings, original windows have been replaced with uPVC. uPVC frames are often chunkier than wooden frames and have a flat uniform finish. As a result they are often a poor replacement for the original or historic timber windows. The harm is particularly great when the configuration is different to the original windows.
- Many of the original stone slate roofs have been replaced with either slate or modern concrete tiles. The loss of the original stone slates has degraded the quality of some of the properties. Surviving stone slate roofs should be retained wherever possible.

Figure 54 - original stone mullions removed and uPVC windows installed

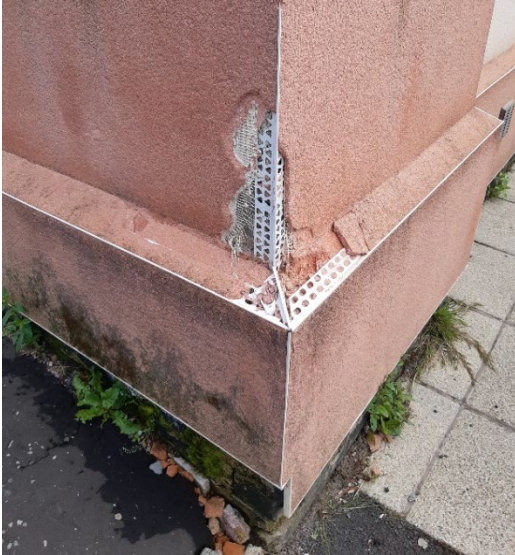
- The Church has been re-rendered, which has obscured some of its historical features. The pink colour of the render does not relate to any other materials within the local area. The render has also started delaminating in areas.

Figure 55 - Render delaminating on the Church

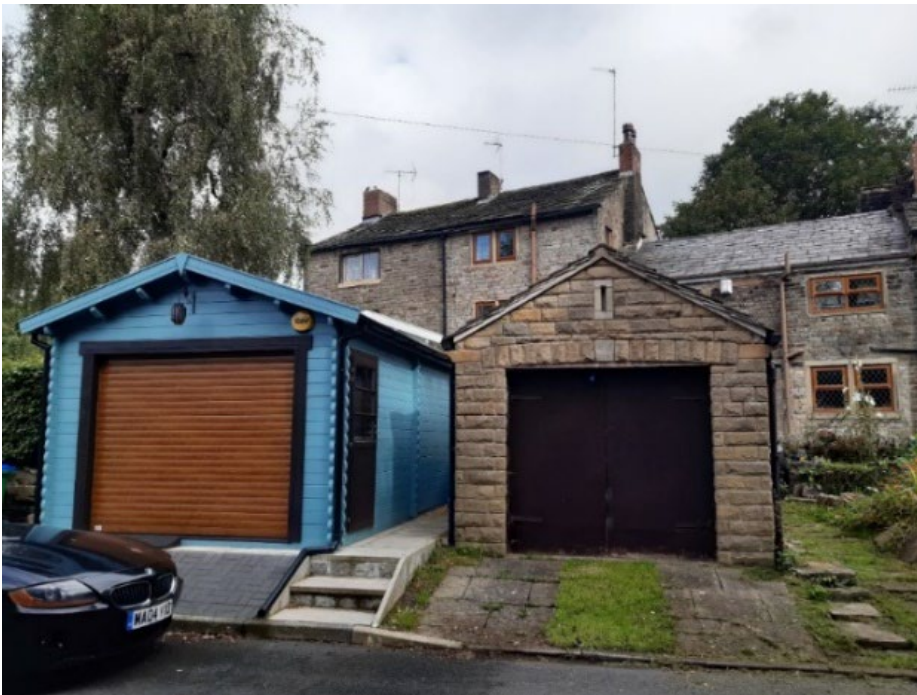
- There are some examples of unsympathetic outbuildings and materials within the Conservation Area.

Figure 56 - Incongruous outbuildings on Syke Lane
